Manhole Inspection Summary

Manhole # S45GG_032MH

Location Address: **BEHIND1212 WOLFE**

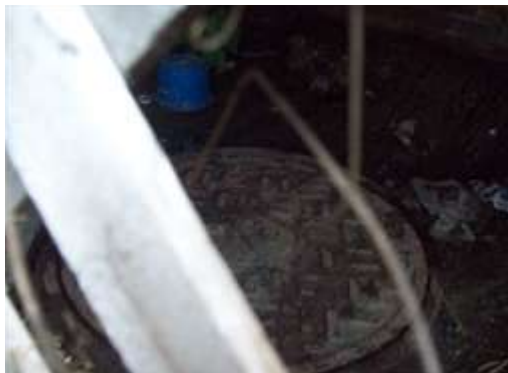
Defect 2

MH under deck

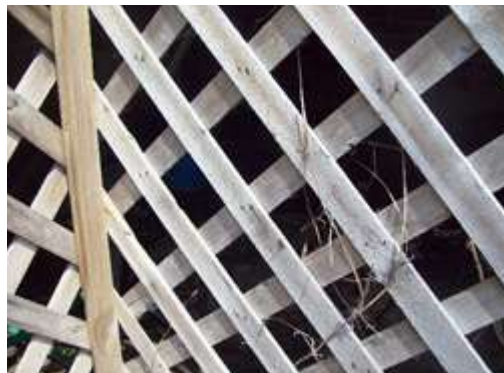
Defect 1

deck
